Manhole Inspection Summary

Manhole # S23A__010MH

Insp Date: **7/27/07 7:22 AM**

Location Address: **614 VINCENT ST**

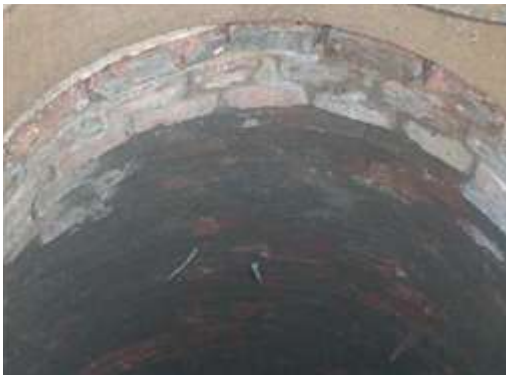
Defect 3

Infiltration: ☐ None ☐ Joint ☐ Cracks ☐ Mortar ☐ Roots ☒ **Wall**

INFILTRATION OF CORBEL

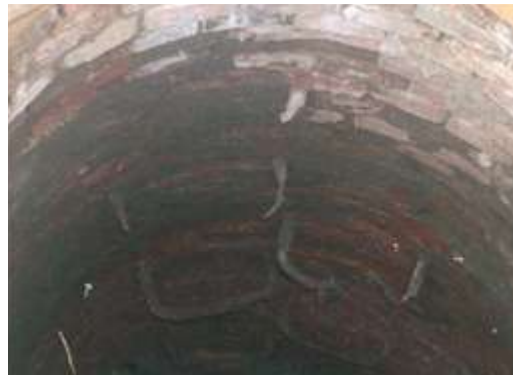
Defect 2

Steps Count: **3** Missing: **3** ☒ **Corroded**

CORRODED AND MISSING STEPS

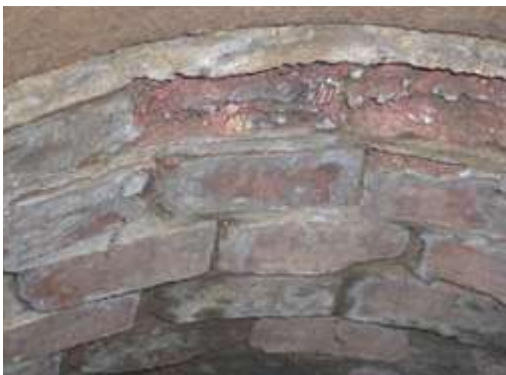
Defect 1

Condition: ☐ Sound ☐ Cracked ☐ Root Intrusion ☐ Loose Brick ☒ **Deteriorated**

DETERIORATION OF CORBEL

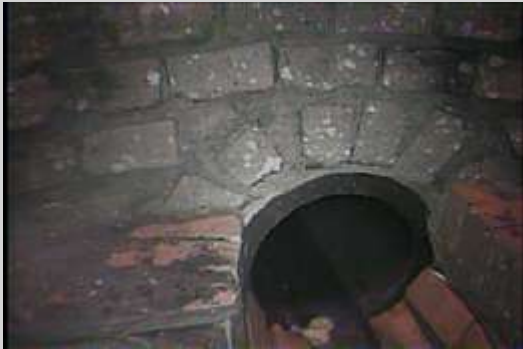
12 O'Clock Outflow

Pipe Height: **8.4** (in.) Rod and Bar (Angled)
Pipe Material: **Clay** ☐ Pipe Lined
Invert Depth: **11.39** (ft.) Flow Characteristics: **Slow**
Deposits: ☐ None ☐ Mud ☐ Sludge ☒ **Debris** ☐ Grease
Silt Depth: **1** (in.) Deposits Extent: **Light**
Infiltration: **None** Pipe Seal Cond: **Sound**

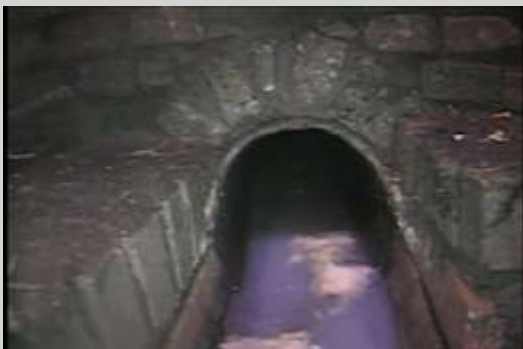
6 O'Clock Inflow

Pipe Height: **8.4** (in.) Rod and Bar (Angled)
Pipe Material: **Clay** ☐ Pipe Lined
Invert Depth: **11.37** (ft.) Flow Characteristics: **Slow**
Deposits: ☐ None ☐ Mud ☐ Sludge ☒ **Debris** ☐ Grease
Silt Depth: **1** (in.) Deposits Extent: **Light**
Infiltration: **None** Pipe Seal Cond: **Sound**

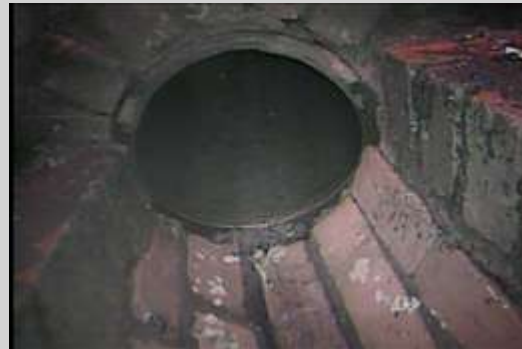
INFILTRATION OF CORBEL
